Assessment of Dam Safety of Coal Combustion Surface Impoundments

Coletto LP, LLC

Coletto Creek Power, LP

Draft Report

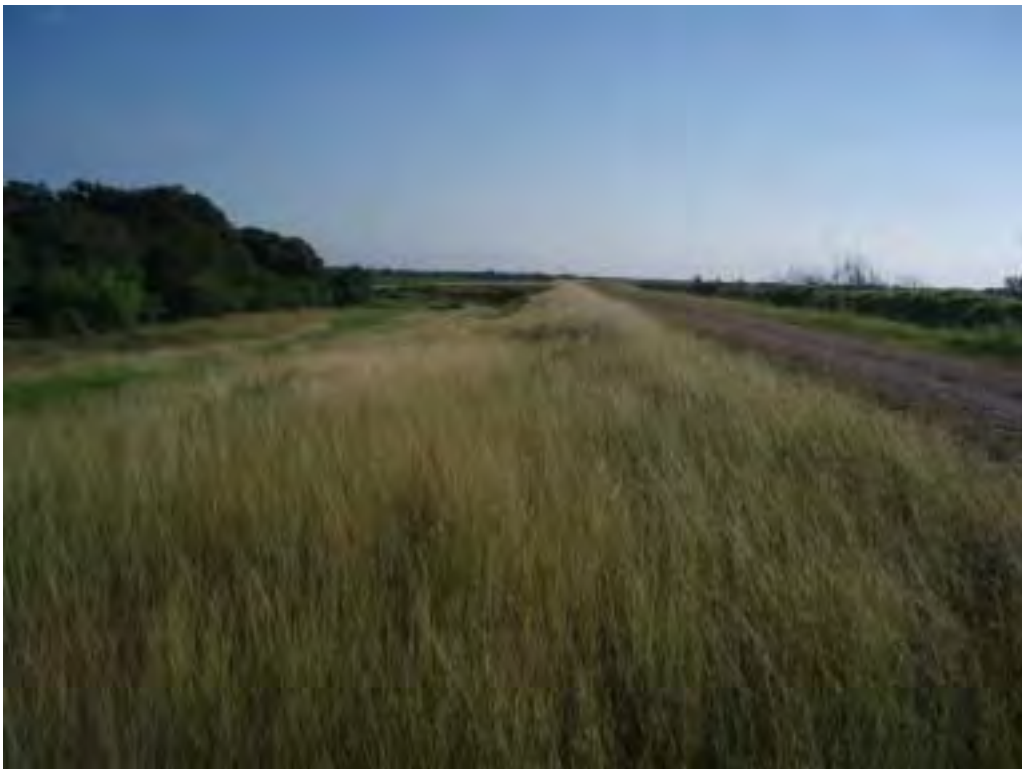
The exterior slopes appear to be in fair condition. The exterior slopes on the north, southern, west, and east embankments were approximately 2.5H:1V (Photos 49, 52, 53, 56, 62, 66, 67, 72, 76, 79, 82, 86, 90, 91, 96, 99, 104, 111, and 114). The northeast slope of the divider embankment between the Primary Ash Pond and Secondary Pond was approximately 3H: 1V (Photos 1 and 15).

Photo No. 76: Primary Ash Pond – West embankment exterior slope, looking northeast.

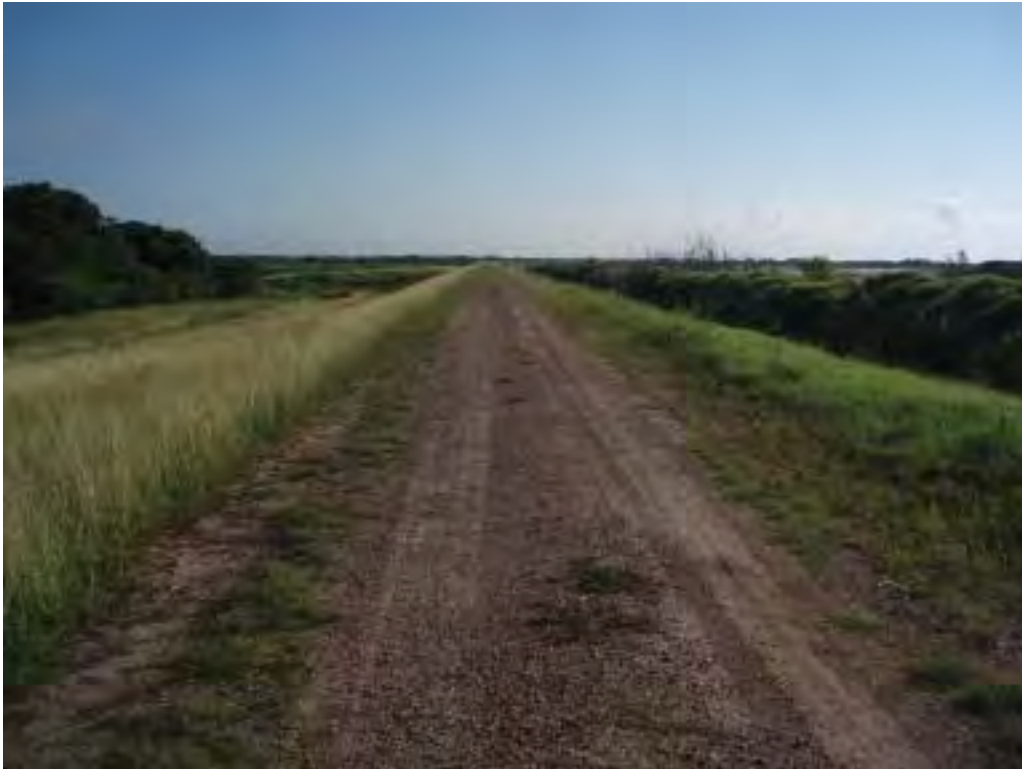
Photo No. 77: Primary Ash Pond – West embankment crest, looking northeast.

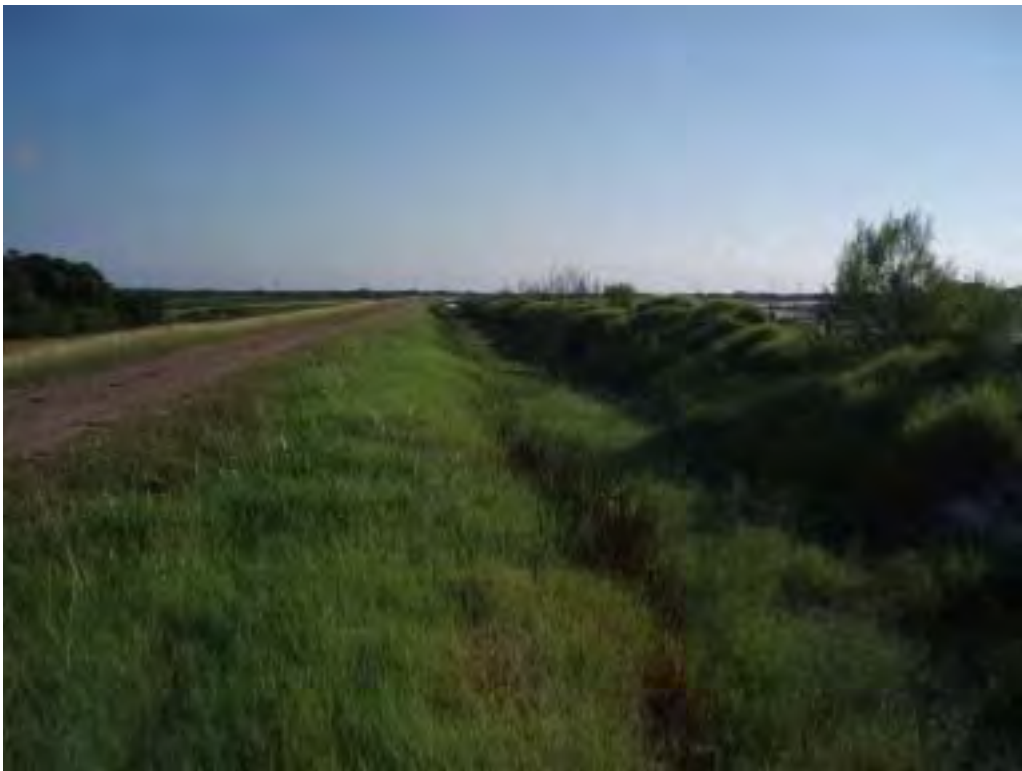
The visible portions of the interior slope generally appeared to be in fair condition (Photos 3, 9, 10, 12, 13, 51, 54, 58, 61, 64, 70, 74, 78, 79, 85, 87, 88, 93, 94, 101, 102, 110, 113, and 116). The north, east, and west interior slope and southwest slope of the divider embankment generally appeared to be armored with a layer of riprap. No riprap was observed on the southern embankments. Grass and brush approximately 24 to 36 inches tall was observed growing in the riprap. An 8-inch-diameter mesquite tree was observed on west end of the north embankment (Photo 54).

Photo No. 78: Primary Ash Pond – West embankment interior slope, looking northeast.

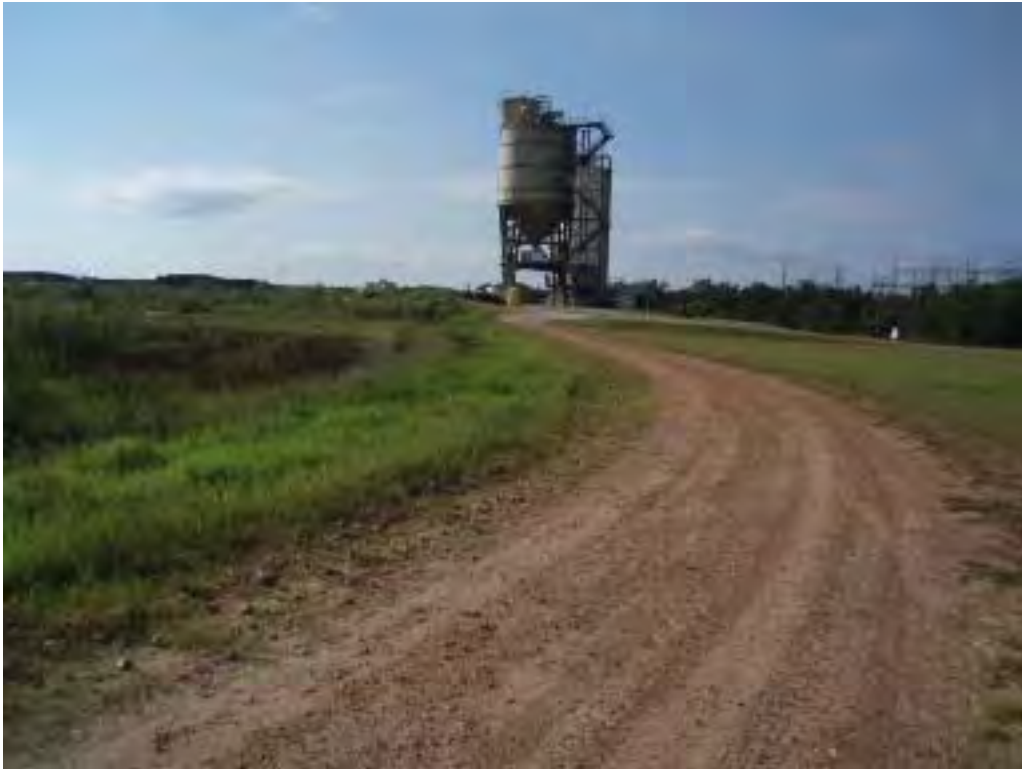
Photo No. 79: Primary Ash Pond – Southwest embankment crest and exterior slope, looking southeast toward Boral Materials Technologies’ fly ash silos.

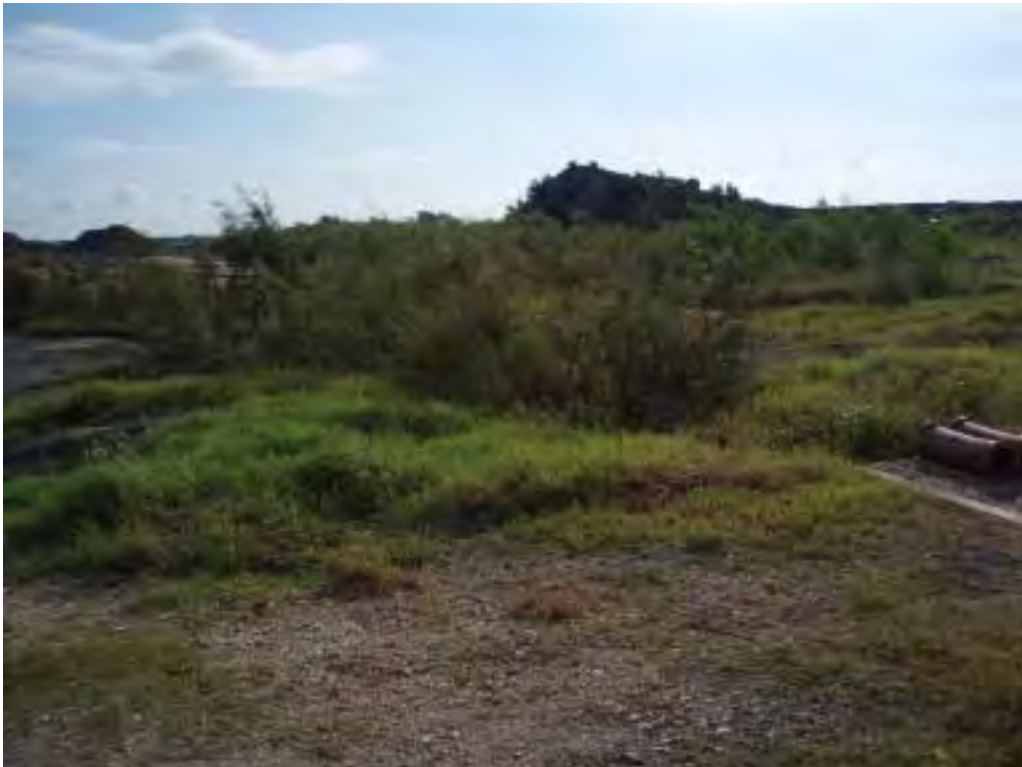
During the site visit, four sets of sluice pipes were observed. The two CCW sluice pipes on the southeast and south embankment appeared to be in fair condition (Photos 80, 81, 83, and 84). The boiler area sump sluice pipe on the west embankment and the demineralizer effluent sluice pipe on the southeast embankment also appeared to be in fair condition (Photos 75 and 85). No seepage was observed where the pipes penetrated through the embankment.

Photo No. 80: Primary Ash Pond – Southwest embankment, looking northeast at fly ash silo sluice area.

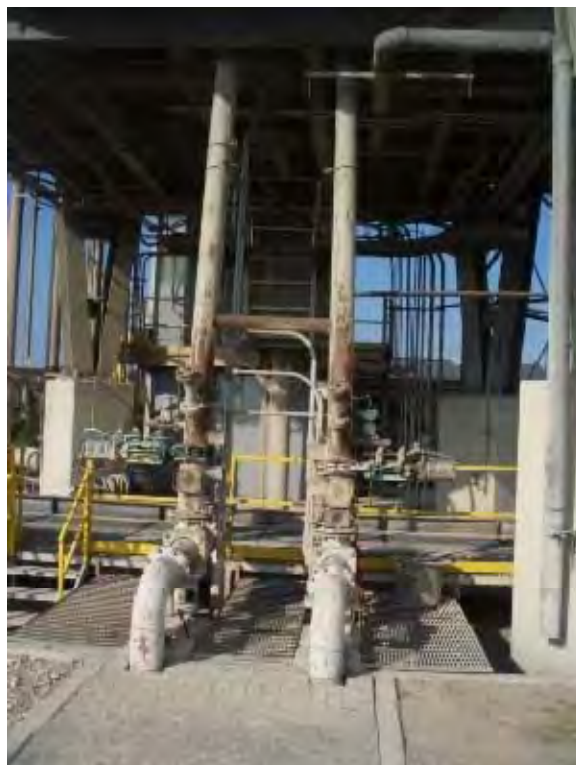
Photo No. 81: Primary Ash Pond – Southwest embankment, looking at two 8-inch-diameter sluices pipes from Boral Material Technologies’ silos.

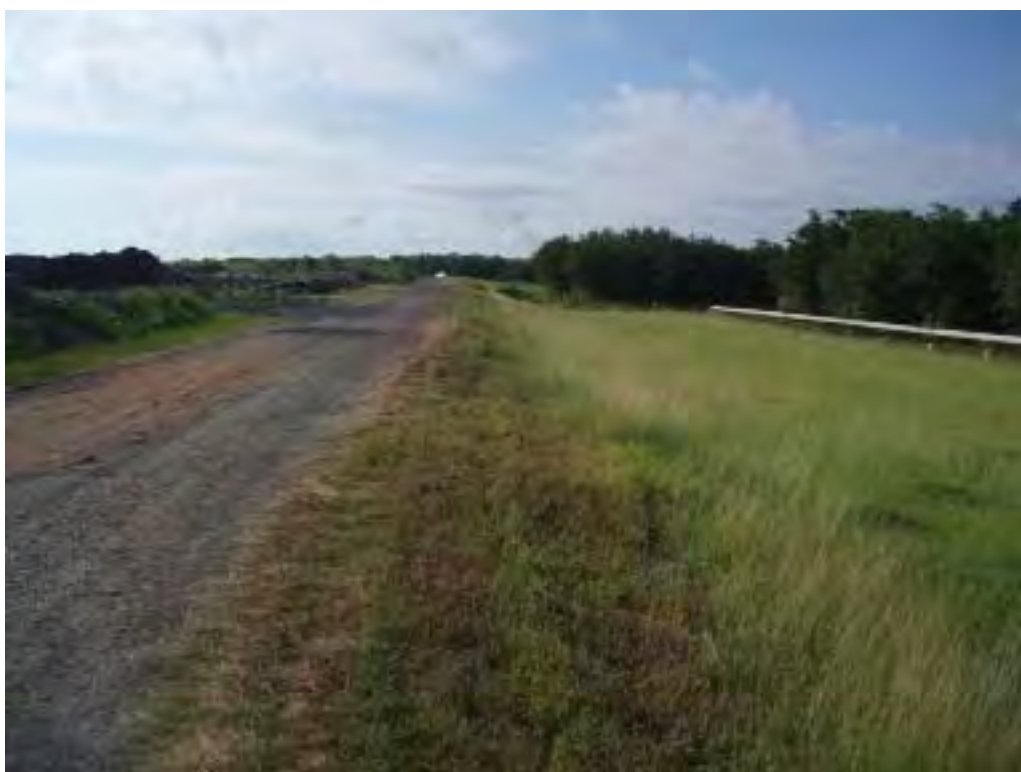
Photo No. 82: Primary Ash Pond – Southwest embankment exterior slope and crest, looking southeast.

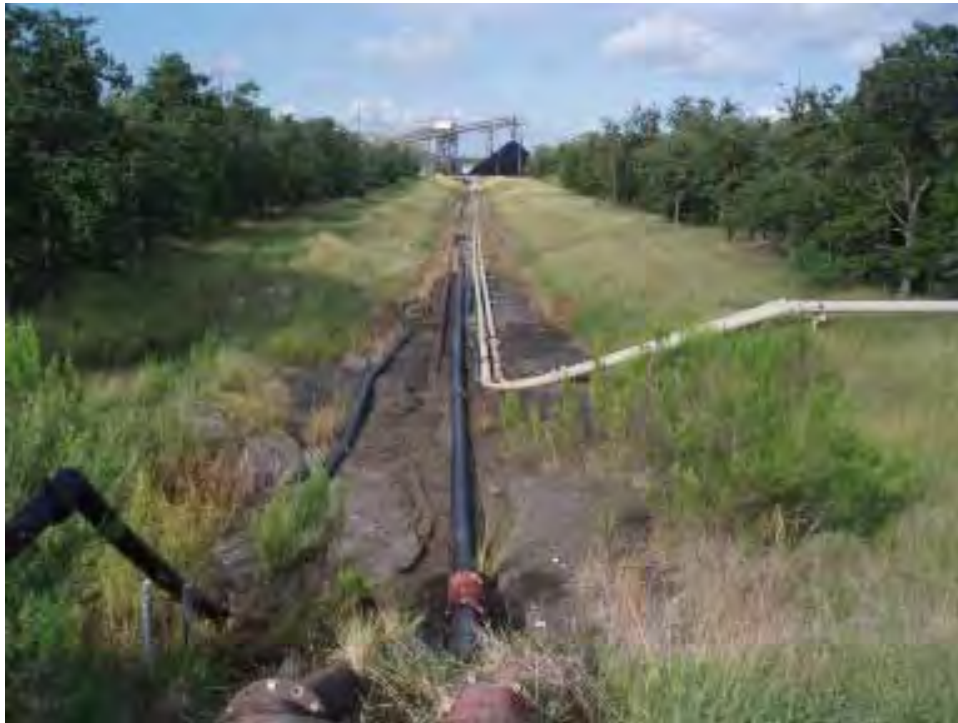
Photo No. 83: Primary Ash Pond – Southwest embankment, looking southwest at sluice pipe trench.

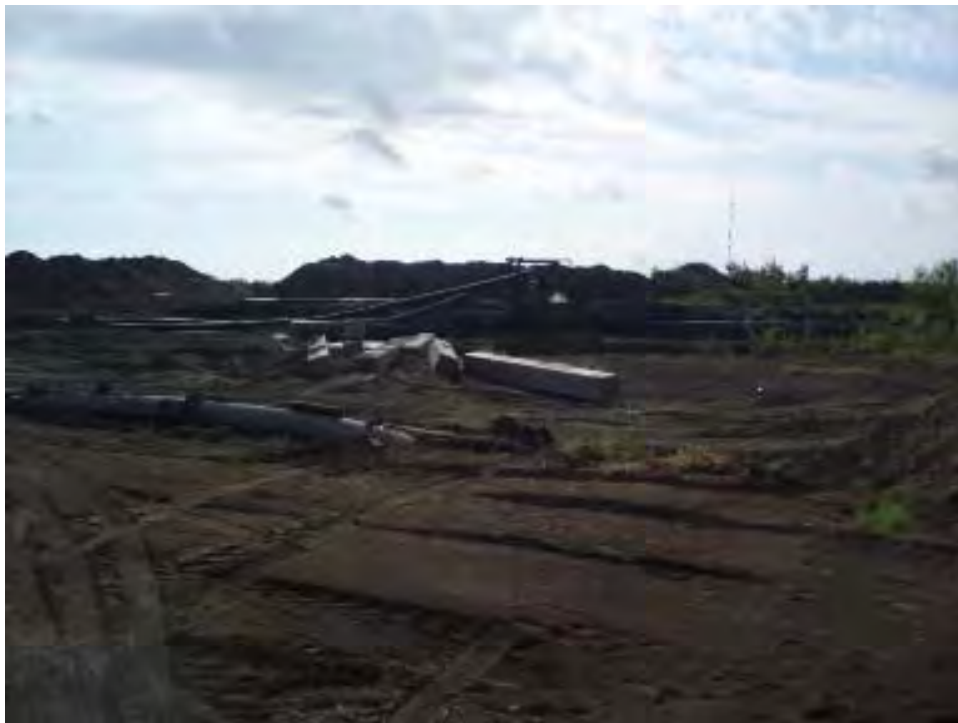
Photo No. 84: Primary Ash Pond – Southwest embankment, looking northeast at sluice pipe discharge into screen processor.

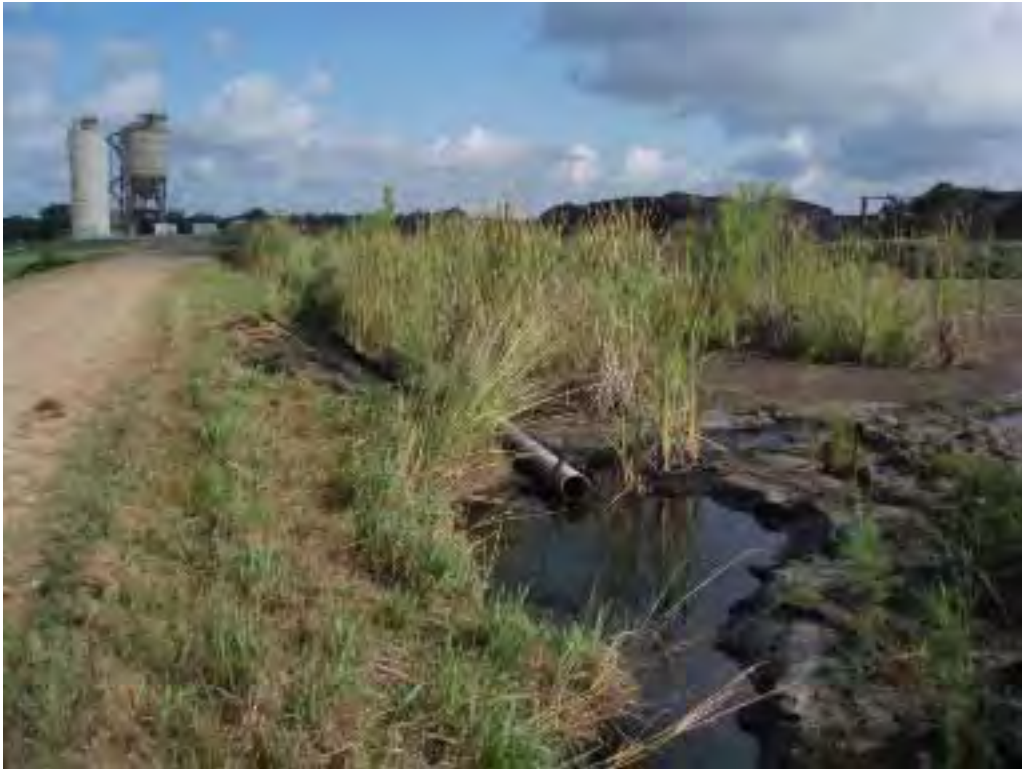
Photo No. 85: Primary Ash Pond – Southwest embankment interior slope, looking northwest at 8-inch-diameter demineralizer effluent pipe.

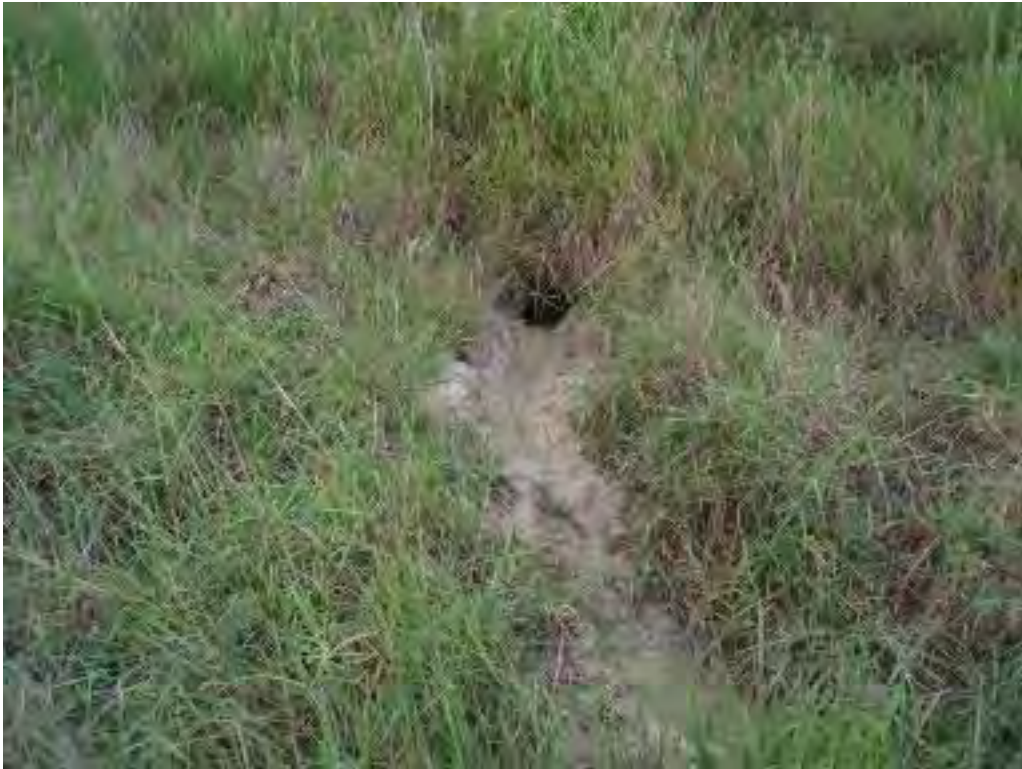
On the southeast embankment two seeps were observed. One of the seeps appeared to have developed at the location of an 8-inch-diameter animal burrow (Photo 97). The other seep observed on the southeast embankment was near the toe of the slope and was approximately 8-feet-long by 2-feet-wide (Photo 98). Flow from the seeps was estimated to be less than 10 gallons per day (gpd).

Photo No. 97: Primary Ash Pond – Southeast embankment exterior slope, looking at 8-inch-diameter rodent burrow hole and seep.

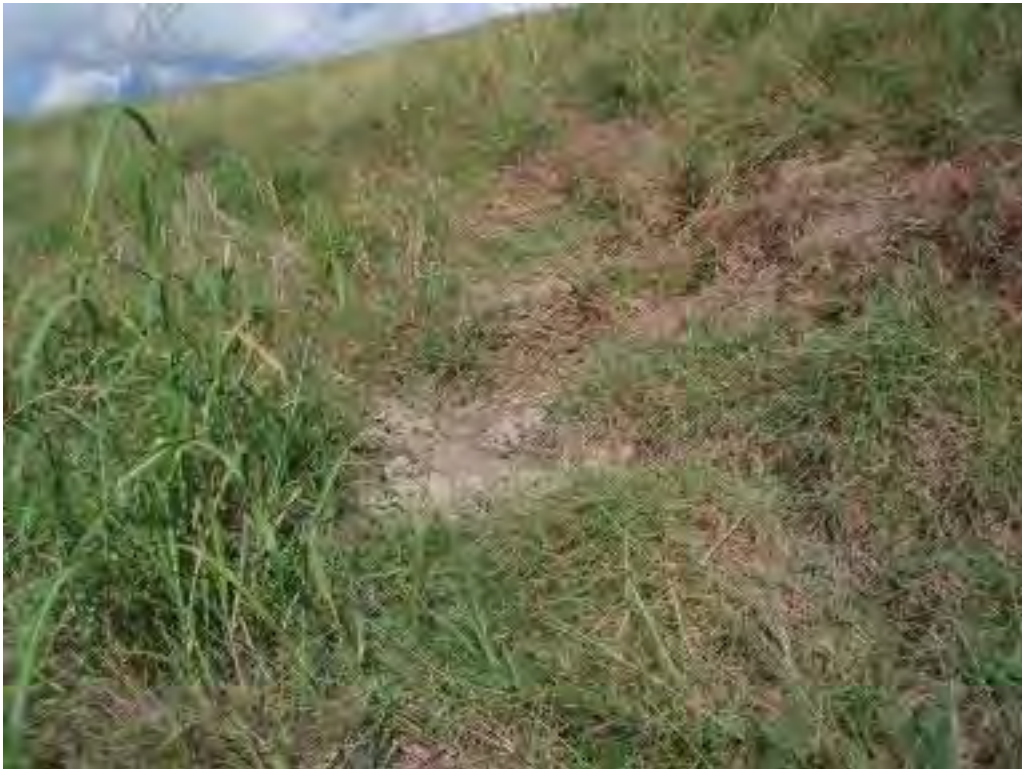
Photo No. 98: Primary Ash Pond – Southeast embankment exterior slope, looking at 8'Lx2'W seep near toe.

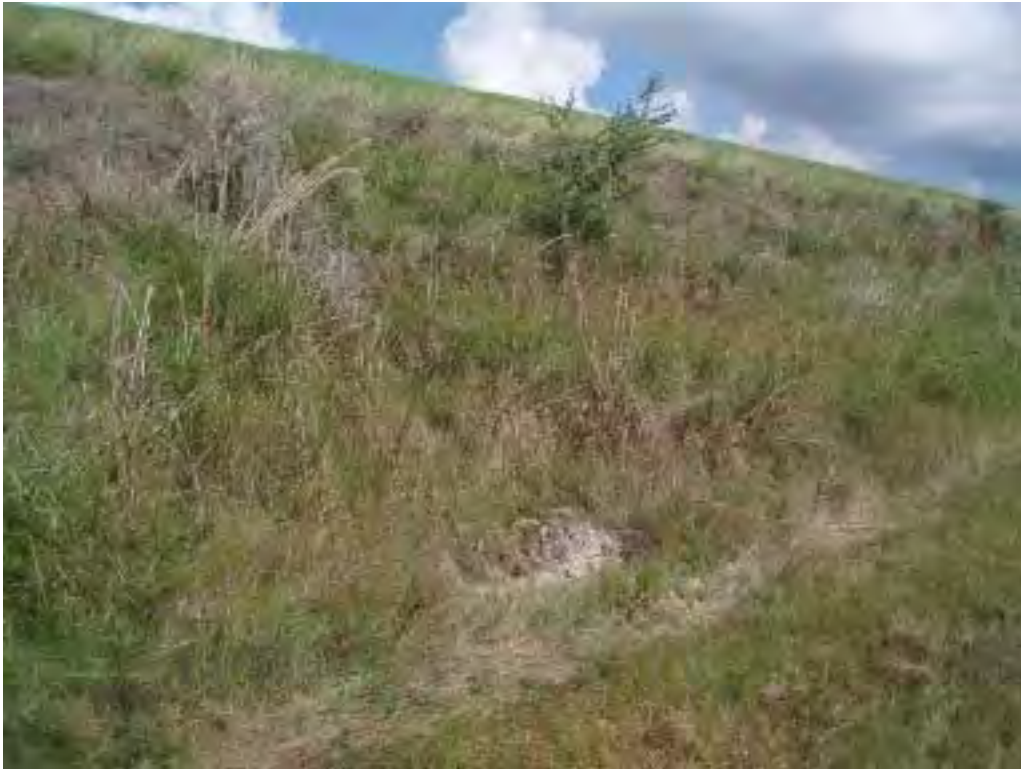
There were multiple seeps observed on the east embankment exterior face and in the toe area. An approximately 40-foot-long by 10-foot-wide seep was observed on the lower third of the slope (Photo 105). To the north of that seep there were more minor seeps that were less than 2-feet-wide and observed near the toe of the slope. These seeps appeared dry and crusted at the time of the site visit. A surface depression approximately 4 feet long by 4 feet wide by 2 feet deep was also observed in the area (Photo 106) of these seeps. A large seepage area approximately 400 feet long by 20 feet wide was observed at the embankment toe area (Photos 107 and 108). The seepage area was saturated, soft, and boggy with standing water up to 12 inches in depth. Well established vegetation, mesquite trees, and hog wallows were also observed in this seepage area. Seepage rates could not be estimated in the area of this large seep due to its extent.

Photo No. 105: Primary Ash Pond – East embankment exterior slope, looking northwest at 40'Lx10'W seep on lower third of the slope.

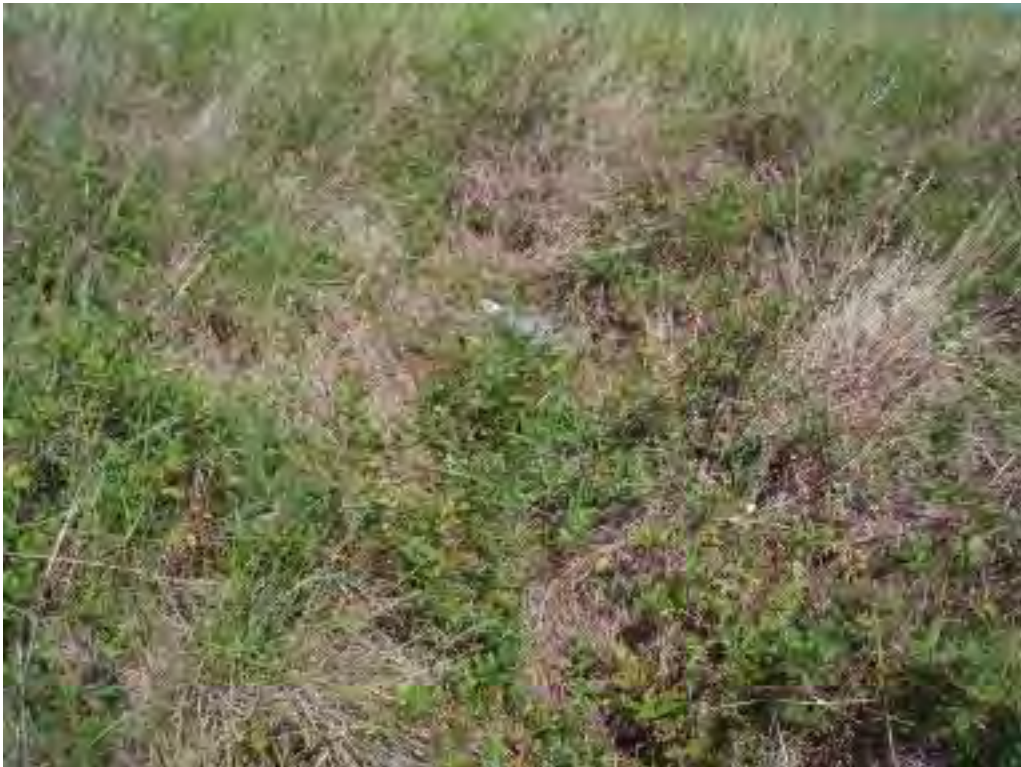
Photo No. 106: Primary Ash Pond – East embankment exterior slope, looking at 4'Wx4'Lx2'D depression. Note apparent dried seepage areas in the vicinity.

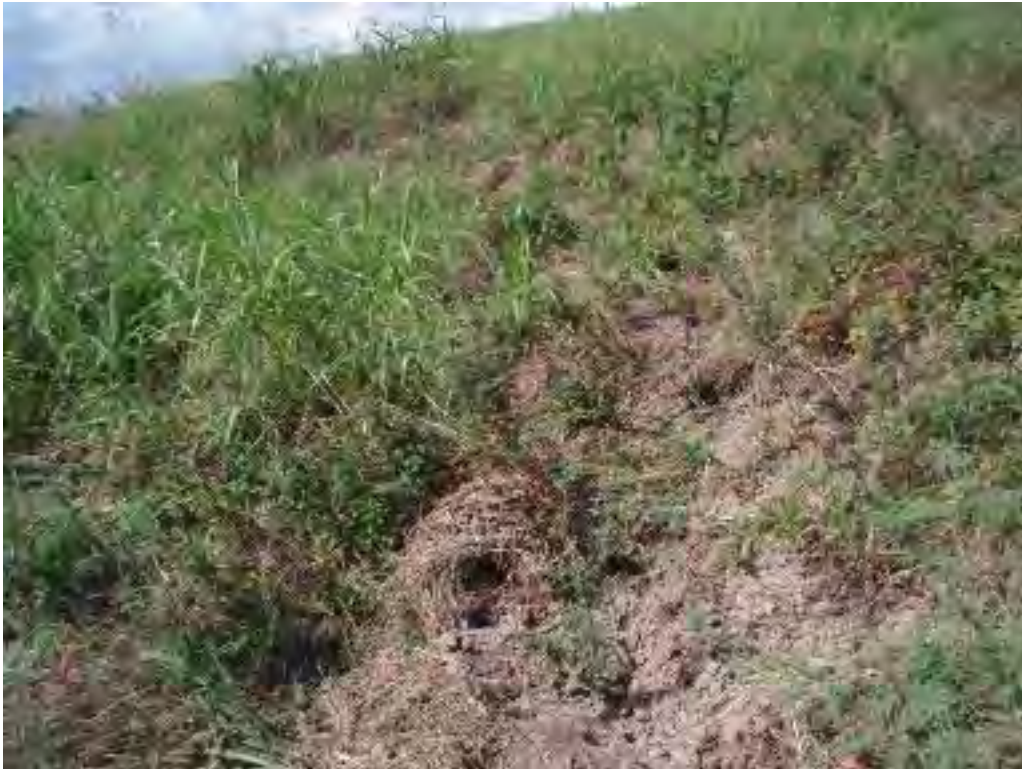
Photo No. 109: Primary Ash Pond – East embankment exterior slope, looking at an area disturbed by animal activity.
